INITIAL SITE INSPECTION OF MOTORCYCLE COLLISIONS WITH ROADSIDE OBJECTS IN NEW JERSEY

Paper Number 09-0450

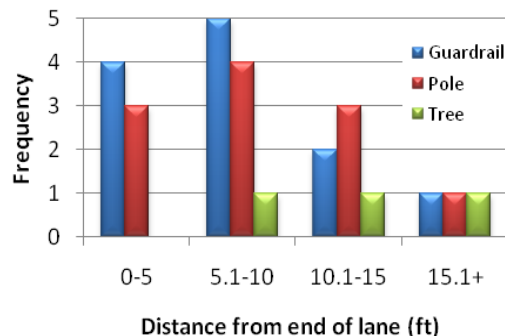
Figure 7. Distance of object from lane edge by object struck.

The distances of the objects from the edge of the lane varied greatly amongst the sites (Figure 7). There were sites where the guardrail was on the edge of the pavement on a street with no shoulder, and others where the guardrail was offset from the edge of the pavement on a road with a significant shoulder.
